2023 ANNUAL DRINKING WATER REPORT

PANORAMA MOUNTAIN RESORT

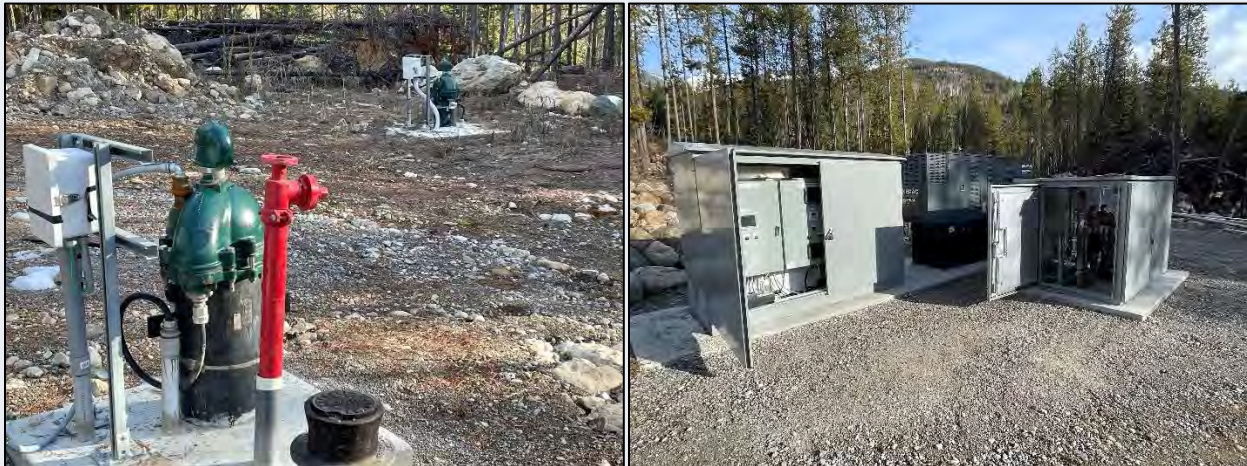
Panorama Well Site

Panorama's source water is from two, 10-inch diameter production wells near the Toby Creek. In 2020, Corix transitioned from a surface water source to a clean groundwater source to alleviate the high levels of turbidity in the water during spring runoff. Well 15-02 has a total depth of 106.5 ft (32.5m) and well 20-03 has a total depth of 124.5 ft (37.9m). Both wells have been drilled into the same semi-confined sand and gravel aquifer system. This system is overlain by sediments containing silt and clay, while it is underlain by bedrock.

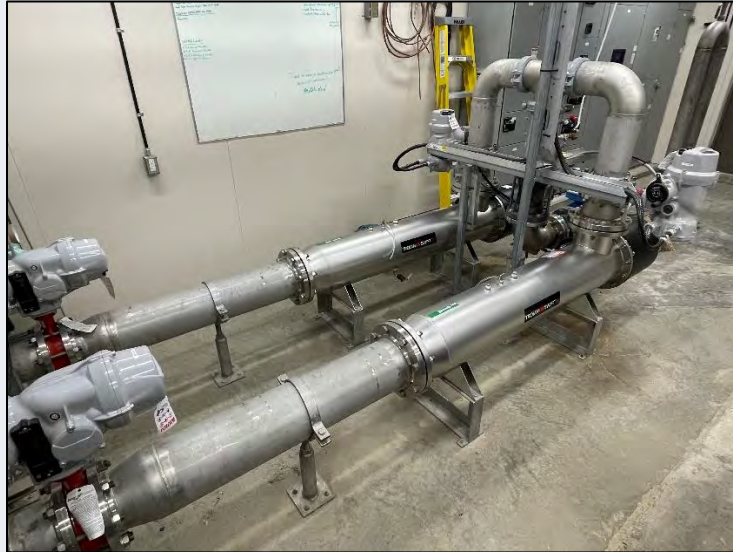
Panorama's source water is continuously pumped to a treatment station located at 2130 Trappers Way. There is continuous online turbidity monitoring for all water entering the treatment station. The first stage of disinfection is UV. Corix operates two Trojan UV Swift SC units. This UV disinfection process provides 99.99% inactivation of pathogens such as *Cryptosporidium* and *Giardia*. The next stage of disinfection is accomplished with chlorine. Corix administers a dosage using 12% Sodium Hypochlorite. The level of chlorine leaving the treatment station is continuously monitored, and is usually around 0.90 mg/L. The combination of using UV technology and chlorine disinfection creates a very efficient disinfection process by inactivating many microorganisms.

Panorama UV disinfection units

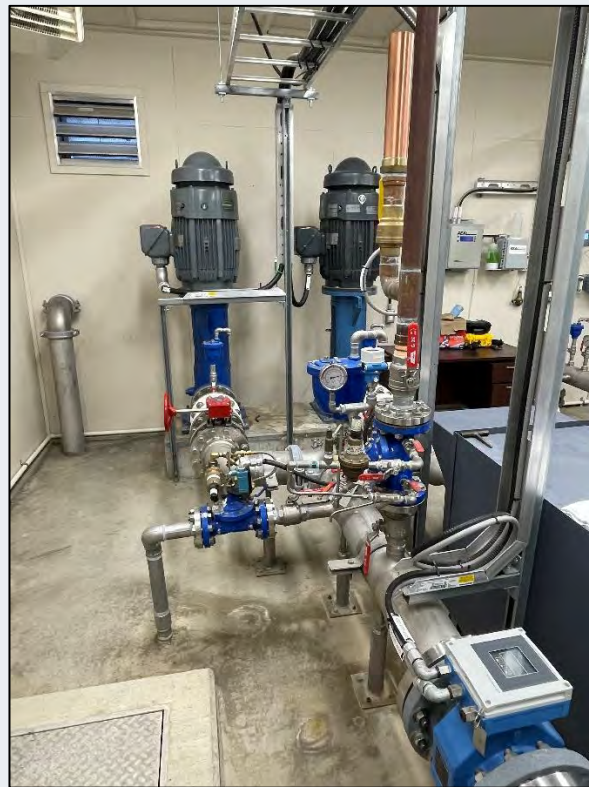
After disinfection is accomplished, the water is pumped into a clear well, which is located underneath the treatment station. This acts as a holding tank, as two booster pumps then move the water from the treatment station to the main resort reservoir. As water demands increase and decrease all tank levels remain constant as well pumps and booster pumps act in unison and modulate their flow rate accordingly.

Treatment Station Booster Pumps

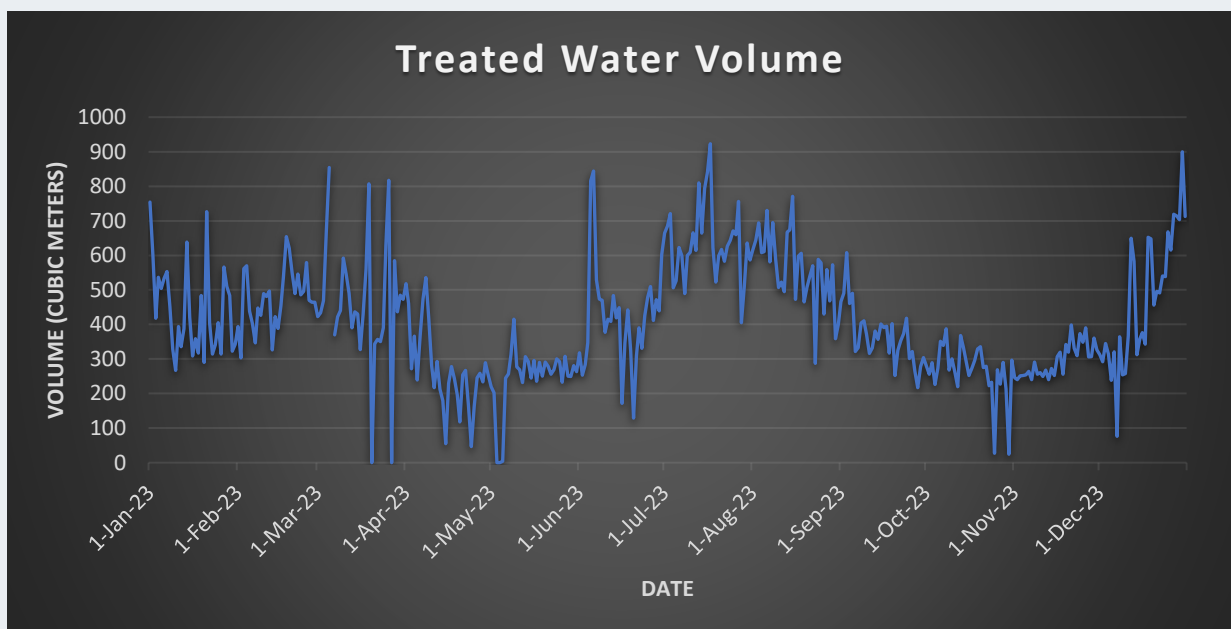
In 2023, Corix treated and distributed approximately 149,280 cubic meters of water (149,280,000L). Figure 1 below illustrates the amount of water that was treated daily over the course of the year. As can be seen, there are fluctuations throughout the year. This is because Panorama is a seasonal resort destination. Higher flows can be expected through winter months (Dec – Apr) and summer months (Jul – Sept) due to higher occupancy rates. Summer irrigation also factors into a higher demand during summer months.

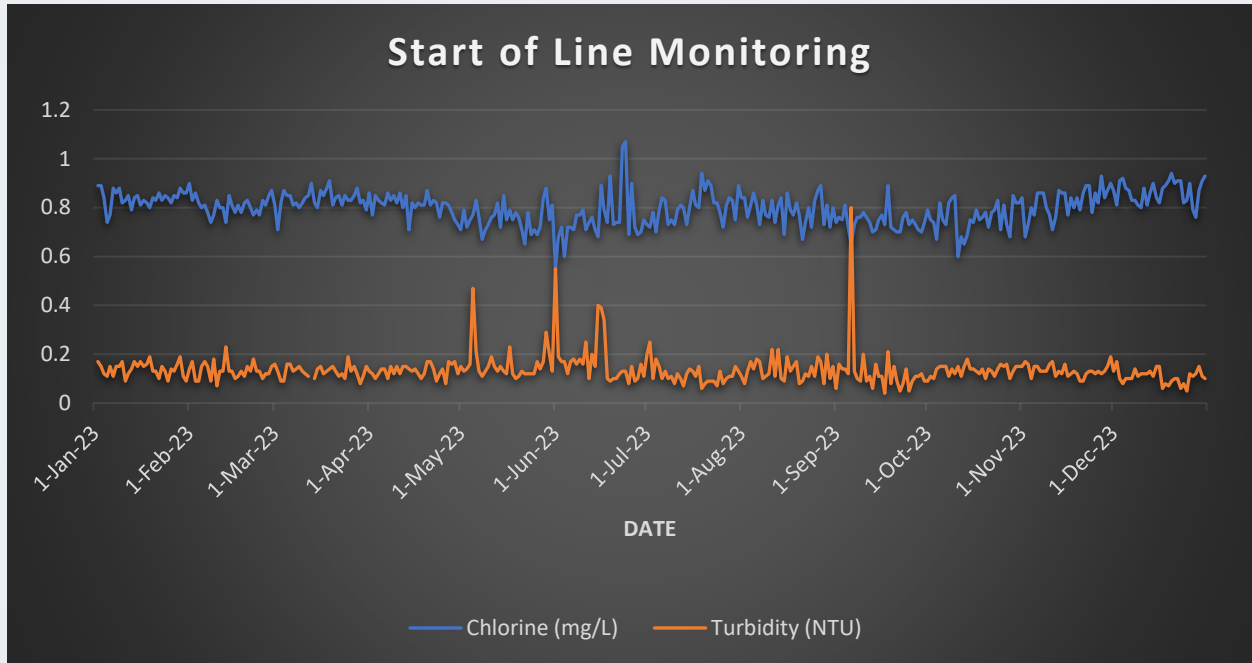
Every day, Corix operators perform a set of daily rounds consisting of operational checks of the well site and booster station. Turbidity and residual chlorine checks are also completed everyday by an operator. Please refer to Figure 2 and Figure 3 for a snapshot of chlorine and turbidity levels found at the start and near the end of the distribution system throughout 2023. By completing these checks at both the start and end of line, this ensures an adequate chlorine residual and turbidity level throughout the entire system.

Chlorine residual concentrations usually range from 0.20 to 2.0 mg/L in many Canadian drinking water distribution systems. Corix operators try to keep the residual around 0.80 mg/L through the system to ensure proper disinfection while minimizing the taste of chlorine for the customer. As noted in Table 1, the average chlorine residual at the start and the end of the distribution system were 0.80 mg/L and 0.76 mg/L respectively.

As seen in Figure 2 & 3 on the following page, turbidity levels did seemingly increase sporadically throughout the year. The increased turbidity levels found in June can be attributed to the flushing program that was being administered at that time. All other spikes above 0.40 NTU can most likely be attributed to operator error in data entry as they were not detected by any continuous monitoring device, nor were they seen in other parts of the distribution system.
